TR-25 Version V.0.20 Sidetone Hardware Mod Note

This modification note only applies to TR-25 transceivers that show V.0.20 on the OLED display upon turn-on.

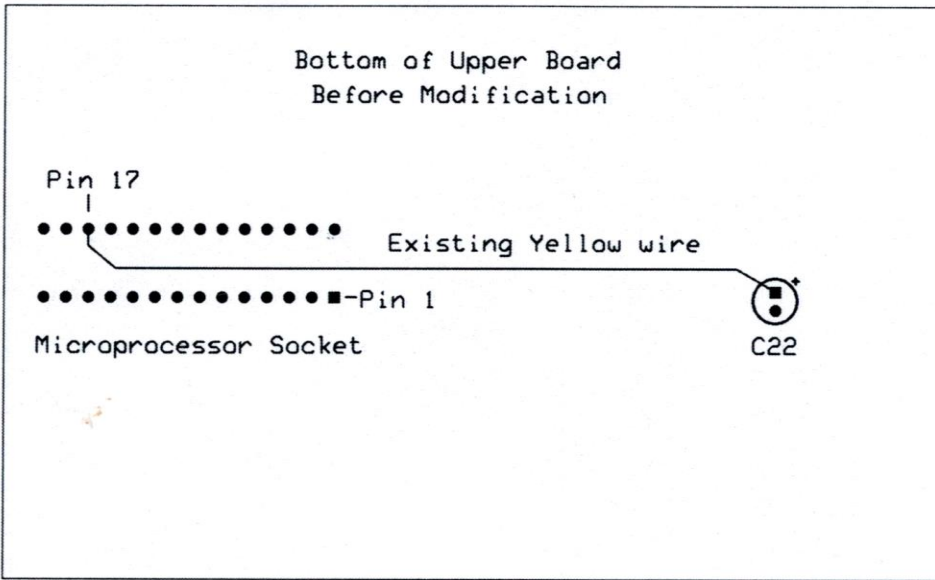
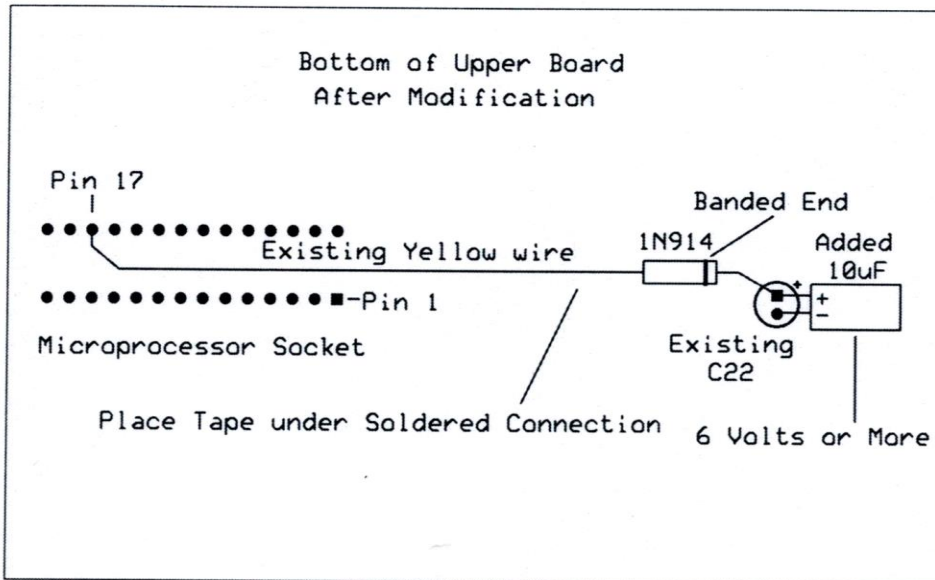
Some users prefer to have a very low sidetone level. When attempting to set the level near the low end of the sidetone level adjustment pot range, you may start to hear transmit-receive switching transients that sound like clicking noises. These are not transmitter clicks, and they only affect the receiver when the sidetone level is low. The fix for these clicks is to slightly extend the the falling edge of the microprocessor-generated receiver gain reduction pulse. This mod is something that you can do yourself if you need a low-level sidetone, and if you feel comfortable with a soldering iron. You should observe standard anti-static precautions such using a static grounding strap, and perhaps working inside a large metal cookie sheet. Or, you may return your unit to me to have this mod installed at no charge. If you use a more moderate sidetone level and are not hearing the clicks, you do not need to be concerned with the mod. No one will be quized if they try this mod themself and something goes wrong. Just return the unit to me for a no-charge fix with no questions ask.

The modification requires that a diode and a 22uF capacitor be added to the upper PC board. The diode (1N914 or similar) is added in series with the yellow wire on the bottom of the upper board that connects the microprocessor pin 17 to the 10uF capacitor C22. An additional 10uF capacitor is then bridged accross the existing 10uF capacitor C22. This added capacitor may be any working voltage above 6 volts. The diode may be a 1N914, 1N4148, or just about any Schottky diode such as a 1N5817. Even the lowley 1N4000 series rectifier diodes will work so long as they don't have too much forward voltage drop. Several 1N4002 and 1N4003 diodes were tried, and all worked fine. If the diode has too much forward voltage drop, and if any of the FETs that receive this pulse have a gate threshold voltage that is at or above the upper specified limit, they may not turn on properly. I think this is more of an abstract possibility than a real issue. I tried about 8 different diodes on three different TR-25 units and all seemed to work just fine. See the drawings for before and after the modification.
